**Flood Control Project Maintenance
Levee Inspections****LMA District Cover Sheet****Spring 2013 Levee Inspection Results****Levee District No. 0009 (Sutter County)**

Levee Inspection Report By Mile - Spring 2013

Waterway				Bank	Unit Miles	Inspection Start/End	Inspector
Unit No. 01 Sutter County, Feather River				Right	6.24	04/23/2013 04/23/2013	Rick Burnett

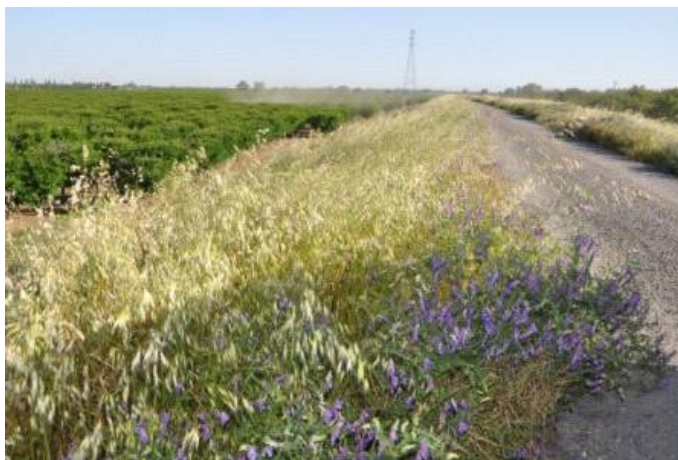
Levee Mile Report Line	4
Start Levee Mile	0.02
End Levee Mile	6.23
Location	Land Side
Category	
Item	Vegetation

Typical L/S seasonal vegetation.

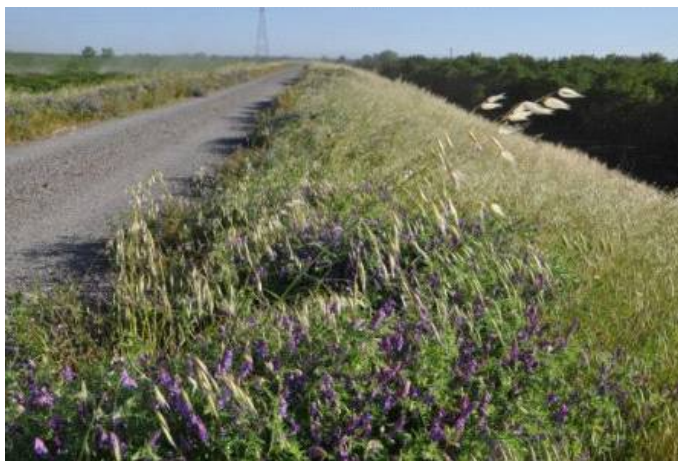
Levee Mile Report Line	5
Start Levee Mile	0.02
End Levee Mile	6.23
Location	Water Side
Category	
Item	Vegetation

Typical W/S seasonal vegetation.

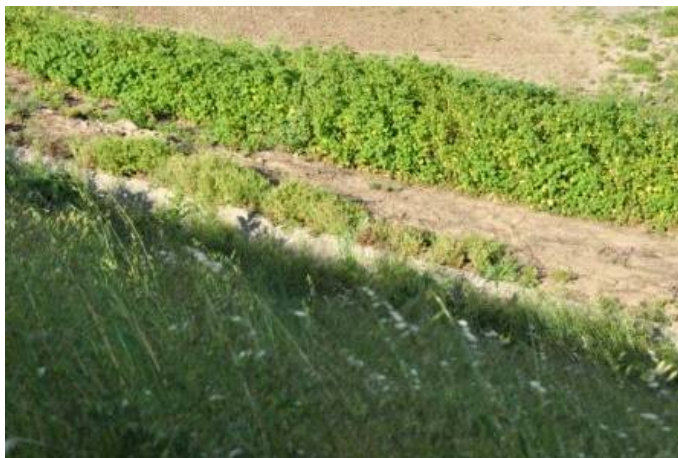
Levee Mile Report Line	6
Start Levee Mile	2.96
End Levee Mile	3.12
Location	Land Side
Category	
Item	Encroachments

Concrete lined ditch at L/S levee toe.

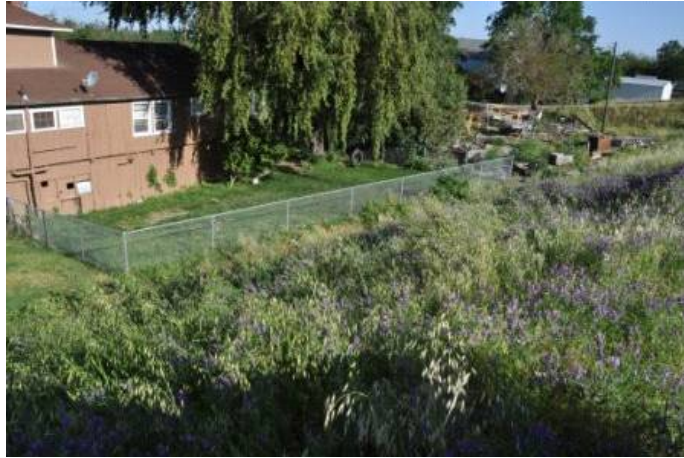
Levee Mile Report Line	7
Start Levee Mile	3.05
End Levee Mile	3.06
Location	Land Side
Category	
Item	Encroachments

L/S fence along levee toe.

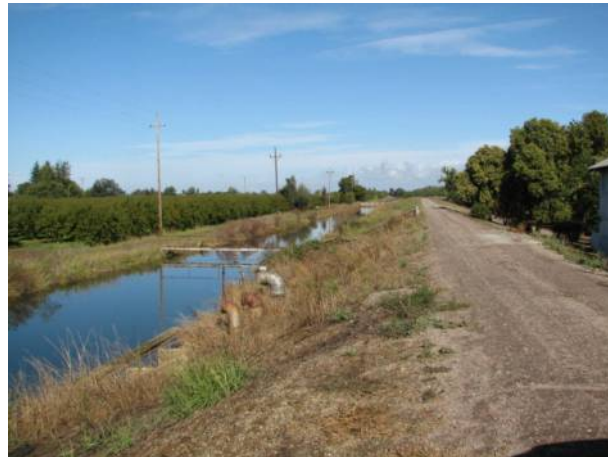
Levee Mile Report Line	10
Start Levee Mile	5.68
End Levee Mile	6.02
Location	Land Side
Category	
Item	Encroachments

Agricultural ditch at landside toe.

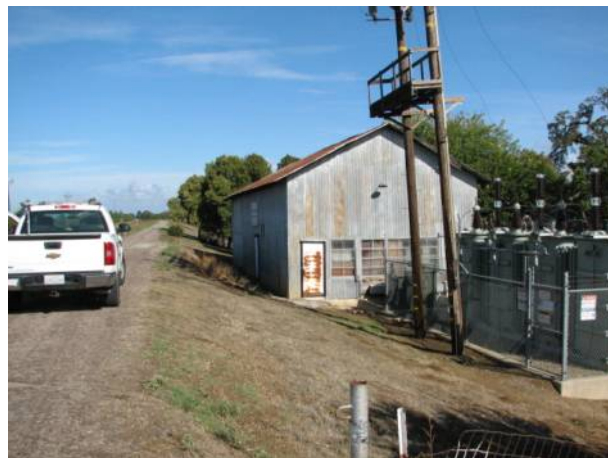
Levee Mile Report Line	11
Start Levee Mile	5.68
End Levee Mile	5.68
Location	Water Side
Category	
Item	Encroachments

Building at the waterside toe.
